Manhole Inspection Report

Date:	04/12/2018	Weather:		Coding:	RZMACP
MH#:	M-404-032	Owner:	NA	Len. Surveyed:	11.2
P.O.#:		Surveyor:	John Kuglmaier	Rim to Invert:	15.0
Customer:		Cert. #:	U-1215-07002349	Wall Material:	Concrete (reinforced)

Street:	Ridge Rd. 20' East of LaSalle St.	Project:	Hobart, IN
City:	Hobart, IN	GPS Northing:	2898098.202
Location:		GPS Easting:	2898098.202
Drain Area:	Northwest	GPS Accuracy:	Sub-Meter
Cover Shape:	Circular	Evidence of Surcharge:	No
Cover Size:	23.0	Potential for Runoff:	None
Comments:

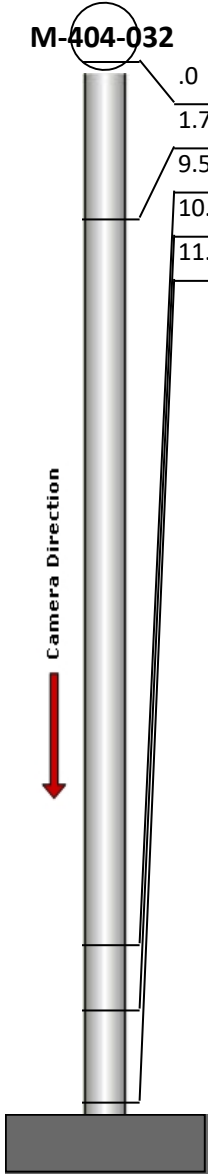
.0	MGP	General Photo	10	NA
	1.7	MGP	General Photo	27	NA
	9.5	IS	Infil Stain	56	NA
	10.2	DAZ	Deposits Attached Other	69	M 3
	11.2	MGO	General Observation	83	NA
