Manhole Inspection Report

Date:	05/16/2018	Weather:		Coding:	RZMACP
MH#:	M-405-014	Owner:	NA	Len. Surveyed:	5.9
P.O.#:		Surveyor:	Jen Costello	Rim to Invert:	6.8
Customer:		Cert. #:	U-907-5518	Wall Material:	Concrete (reinforced)

Street:	LaSalle Pl. 383' North of 3rd St.	Project:	Hobart, IN
City:	Hobart, IN	GPS Northing:	41.53390121
Location:		GPS Easting:	-87.28234863
Drain Area:	West	GPS Accuracy:	Nearest Meter
Cover Shape:	Circular	Evidence of Surcharge:	No
Cover Size:	22.5	Potential for Runoff:	None
Comments:

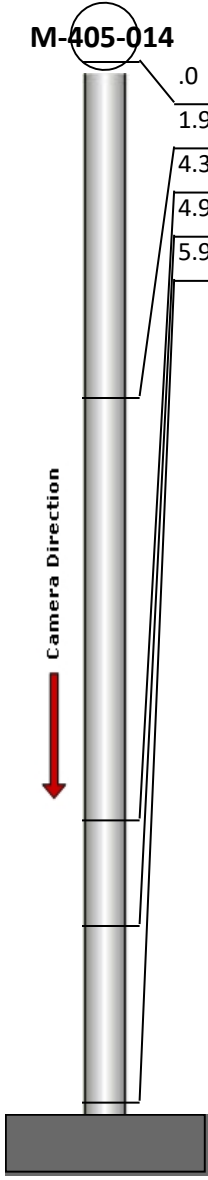
.0	MGO	General Observation	10	NA
	1.9	MGO	General Observation	28	NA
	4.3	FM	Fracture Multiple	45	S 4
	4.9	DSGV	Deposits Settled Gravel	57	M 2
	5.9	MGO	General Observation	70	NA
