Manhole Inspection Report

Date:	05/17/2018	Weather:		Coding:	RZMACP
MH#:	M-405-036	Owner:	NA	Len. Surveyed:	8.5
P.O.#:		Surveyor:	Jen Costello	Rim to Invert:	9.5
Customer:		Cert. #:	U-907-5518	Wall Material:	Concrete (reinforced)

Street:	West 3rd Pl. 146' East of Crestwood	Project:	Hobart, IN
City:	Hobart, IN	GPS Northing:	2897065.355
Location:		GPS Easting:	2897065.355
Drain Area:	West	GPS Accuracy:	Sub-Meter
Cover Shape:	Circular	Evidence of Surcharge:	No
Cover Size:	22.5	Potential for Runoff:	None
Comments:

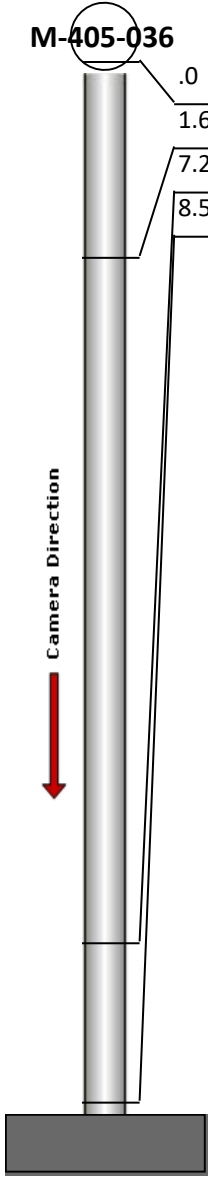
.0	MGO	General Observation	10	NA
	1.6	MGO	General Observation	26	NA
	7.2	OBM	Obstacle Pipe Material	51	M 2
	8.5	MGO	General Observation	65	NA
