Manhole Inspection Report

Date:	04/20/2018	Weather:		Coding:	RZMACP
MH#:	M-405-044	Owner:	NA	Len. Surveyed:	15.3
P.O.#:		Surveyor:	Jen Costello	Rim to Invert:	18.5
Customer:		Cert. #:	U-907-5518	Wall Material:	Brick

Street:	3rd St. 128' East of Softwood Dr.	Project:	Hobart, IN
City:	Hobart, IN	GPS Northing:	0.0
Location:		GPS Easting:	0.0
Drain Area:	West	GPS Accuracy:	Nearest Meter
Cover Shape:	Square	Evidence of Surcharge:	No
Cover Size:	23.0	Potential for Runoff:	None
Comments:

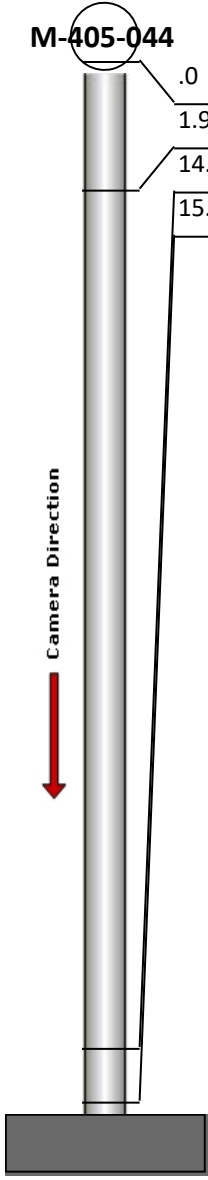
.0	MGO	General Observation	11	NA
	1.9	MGP	General Photo	28	NA
	14.5	OBR	Obstacle Rocks	67	M 2
	15.3	MGO	General Observation	81	NA
