Manhole Inspection Report

Date:	05/17/2018	Weather:		Coding:	RZMACP
MH#:	M-405-051	Owner:	NA	Len. Surveyed:	7.9
P.O.#:		Surveyor:	Jen Costello	Rim to Invert:	8.2
Customer:		Cert. #:	U-907-5518	Wall Material:	Concrete (reinforced)

Street:	150' North of 3rd St. West of Oakwo	Project:	Hobart, IN
City:	Hobart, IN	GPS Northing:	41.5332756
Location:		GPS Easting:	-87.28543091
Drain Area:	West	GPS Accuracy:	Nearest Meter
Cover Shape:	Circular	Evidence of Surcharge:	No
Cover Size:	22.5	Potential for Runoff:	None
Comments:

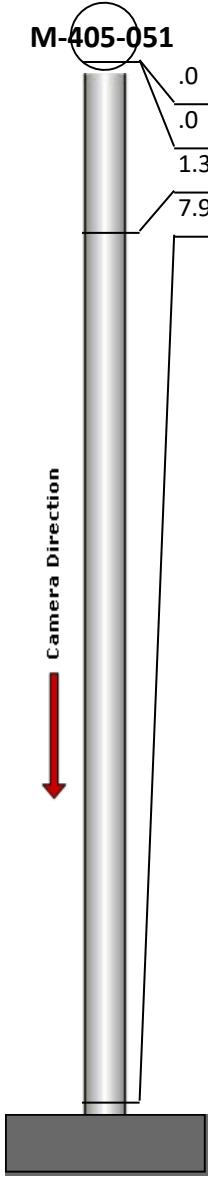
.0	MGO	General Observation	10	NA
	.0	FM	Fracture Multiple	20	S 4
	1.3	MGO	General Observation	35	NA
	7.9	DSGV	Deposits Settled Gravel	62	M 2
