Manhole Inspection Report

Date:	05/17/2018	Weather:		Coding:	RZMACP
MH#:	M-405-051	Owner:	NA	Len. Surveyed:	7.9
P.O.#:		Surveyor:	Jen Costello	Rim to Invert:	8.5
Customer:		Cert. #:	U-907-5518	Wall Material:	Concrete (reinforced)

Street:	150' North of 3rd St. West of Oakwo	Project:	Hobart, IN
City:	Hobart, IN	GPS Northing:	41.53325272
Location:		GPS Easting:	-87.28412628
Drain Area:	West	GPS Accuracy:	Nearest Meter
Cover Shape:	Circular	Evidence of Surcharge:	No
Cover Size:	22.5	Potential for Runoff:	None
Comments:

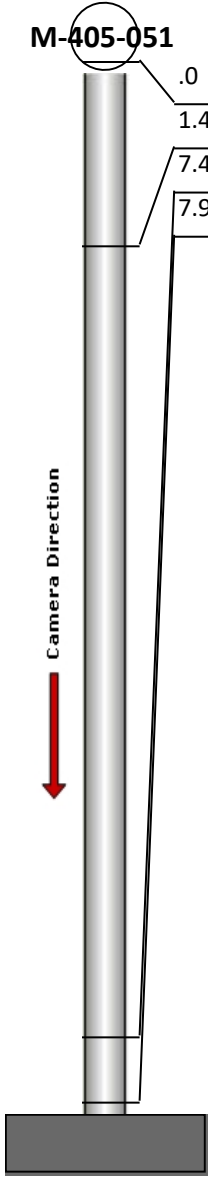
.0	MGO	General Observation	10	NA
	1.4	MGO	General Observation	26	NA
	7.4	DSF	Deposits Settled Fine	51	M 2
	7.9	MGO	General Observation	64	NA
