Manhole Inspection Report

Date:	05/16/2018	Weather:		Coding:	RZMACP
MH#:	M-405-053	Owner:	NA	Len. Surveyed:	4.8
P.O.#:		Surveyor:	Jen Costello	Rim to Invert:	5.5
Customer:		Cert. #:	U-907-5518	Wall Material:	Concrete (reinforced)

Street:	South of West 2nd Pl. 92' West of O	Project:	Hobart, IN
City:	Hobart, IN	GPS Northing:	41.53434372
Location:		GPS Easting:	-87.28517151
Drain Area:	West	GPS Accuracy:	Nearest Meter
Cover Shape:	Circular	Evidence of Surcharge:	No
Cover Size:	22.5	Potential for Runoff:	None
Comments:

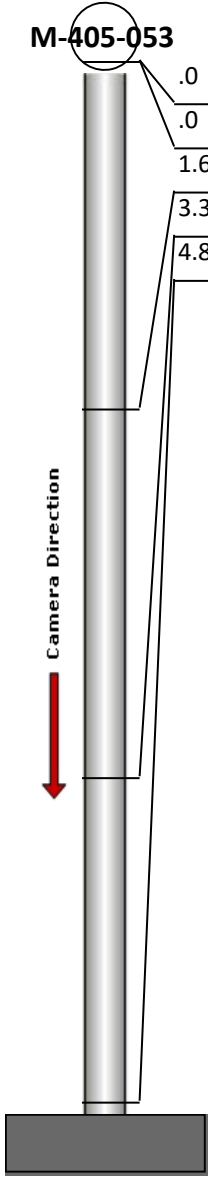
.0	MGO	General Observation	10	NA
	.0	CM	Crack Multiple	20	S 3
	1.6	MGO	General Observation	37	NA
	3.3	OBZ	Obstacle Other	53	M 2
	4.8	MGO	General Observation	68	NA
