Manhole Inspection Report

Date:	04/24/2018	Weather:		Coding:	RZMACP
MH#:	M-407-005	Owner:	NA	Len. Surveyed:	6.5
P.O.#:		Surveyor:	John Kuglmaier	Rim to Invert:	6.8
Customer:		Cert. #:	U-1215-07002349	Wall Material:	Concrete (reinforced)

Street:	On Lake View Dr. South of 10th St.	Project:	Hobart, IN
City:	Hobart, IN	GPS Northing:	2898881.243
Location:		GPS Easting:	2898881.243
Drain Area:	Southwest	GPS Accuracy:	Sub-Meter
Cover Shape:	Circular	Evidence of Surcharge:	No
Cover Size:	22.5	Potential for Runoff:	None
Comments:

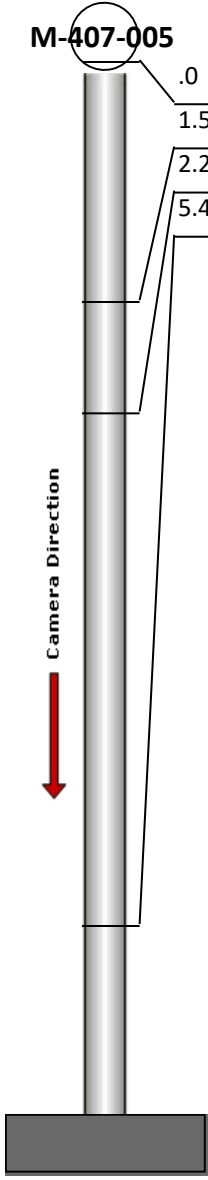
.0	MGP	General Photo	10	NA
	1.5	RFJ	Roots Fine Joint	25	M 1
	2.2	MGP	General Photo	40	NA
	5.4	MGO	General Observation	60	NA
