Manhole Inspection Report

Date:	03/23/2018	Weather:		Coding:	RZMACP
MH#:	M-408-002	Owner:	NA	Len. Surveyed:	21.8
P.O.#:		Surveyor:	John Kuglmaier	Rim to Invert:	21.8
Customer:		Cert. #:	U-1215-07002349	Wall Material:	Concrete (reinforced)

Street:	North of 61st Ave. 43' East of Clay St	Project:	Hobart, IN
City:	Hobart, IN	GPS Northing:	0.0
Location:		GPS Easting:	0.0
Drain Area:	Southwest	GPS Accuracy:	Nearest Meter
Cover Shape:	Circular	Evidence of Surcharge:	No
Cover Size:	22.5	Potential for Runoff:	None
Comments:

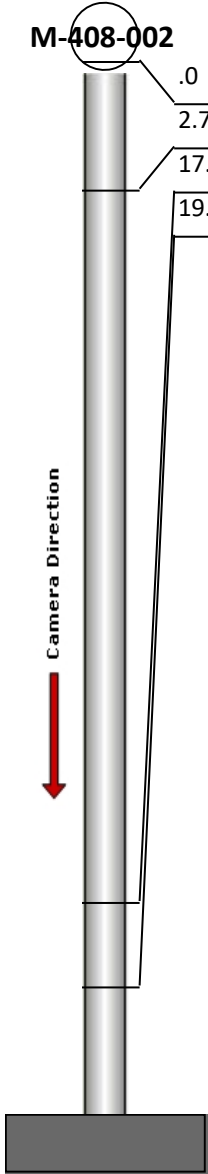
M-408-002				
	.0	MGP	General Photo	10	NA
	2.7	MGP	General Photo	29	NA
	17.6	IS	Infil Stain	73	NA
	19.4	MGO	General Observation	88	NA
