Manhole Inspection Report

Date:	04/12/2018	Weather:		Coding:	RZMACP
MH#:	M-503-001	Owner:	NA	Len. Surveyed:	12.2
P.O.#:		Surveyor:	John Kuglmaier	Rim to Invert:	13.2
Customer:		Cert. #:	U-1215-07002349	Wall Material:	Concrete (reinforced)

Street:	Wisconsin St. 29' North of 40th Plac	Project:	Hobart, IN
City:	Hobart, IN	GPS Northing:	2901770.882
Location:		GPS Easting:	2901770.882
Drain Area:	Northwest	GPS Accuracy:	Sub-Meter
Cover Shape:	Circular	Evidence of Surcharge:	Yes
Cover Size:	23.0	Potential for Runoff:	None
Comments:

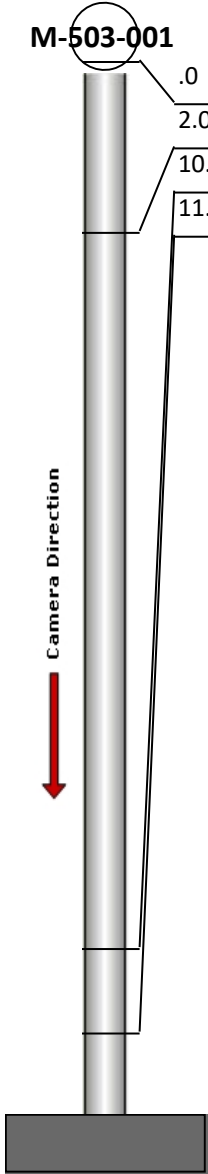
Position	Code	Observation	Video (sec)	Grade

.0	MGP	General Photo	10	NA
	2.0	MGP	General Photo	28	NA
	10.4	DSF	Deposits Settled Fine	58	M 2
	11.4	MGO	General Observation	72	NA
