# Manhole Inspection Report

Date:	04/09/2018	Weather:		Coding:	RZMACP
MH#:	M-503-009	Owner:	NA	Len. Surveyed:	9.3
P.O.#:		Surveyor:	John Kuglmaier	Rim to Invert:	10.8
Customer:		Cert. #:	U-1215-07002349	Wall Material:	Concrete (reinforced)

Street:	164' West of Wisconsin St. 161' North	Project:	Hobart, IN
City:	Hobart, IN	GPS Northing:	2901613.288
Location:		GPS Easting:	2901613.288
Drain Area:	Northwest	GPS Accuracy:	Sub-Meter
Cover Shape:	Circular	Evidence of Surcharge:	Yes
Cover Size:	23.0	Potential for Runoff:	None
Comments:

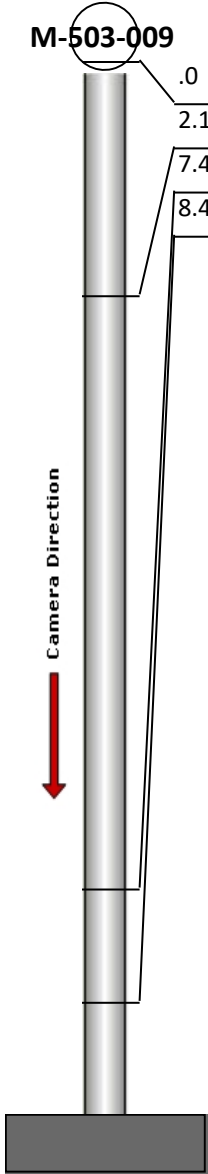
.0	MGP	General Photo	10	NA
	2.1	MGP	General Photo	28	NA
	7.4	DSF	Deposits Settled Fine	52	M 2
	8.4	MGO	General Observation	66	NA
