Manhole Inspection Report

Date:	04/09/2018	Weather:		Coding:	RZMACP
MH#:	M-503-013	Owner:	NA	Len. Surveyed:	6.8
P.O.#:		Surveyor:	John Kuglmaier	Rim to Invert:	8.0
Customer:		Cert. #:	U-1215-07002349	Wall Material:	Concrete (reinforced)

Street:	Virginia St. 239' South of 39th PL.	Project:	Hobart, IN
City:	Hobart, IN	GPS Northing:	2901027.78
Location:		GPS Easting:	2901027.78
Drain Area:	Northwest	GPS Accuracy:	Sub-Meter
Cover Shape:	Circular	Evidence of Surcharge:	No
Cover Size:	23.0	Potential for Runoff:	None
Comments:

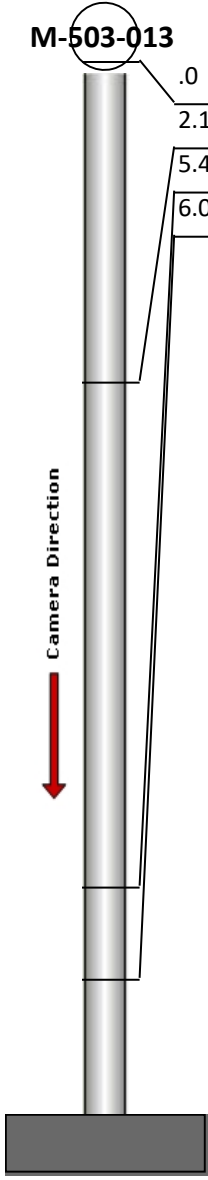
.0	MGP	General Photo	10	NA
	2.1	MGP	General Photo	28	NA
	5.4	DSF	Deposits Settled Fine	48	M 3
	6.0	MGO	General Observation	61	NA
