Manhole Inspection Report

Date:	04/09/2018	Weather:		Coding:	RZMACP
MH#:	M-503-016	Owner:	NA	Len. Surveyed:	8.4
P.O.#:		Surveyor:	John Kuglmaier	Rim to Invert:	9.5
Customer:		Cert. #:	U-1215-07002349	Wall Material:	Concrete (reinforced)

Street:	39th PL. 164' West of Wisconsin St.	Project:	Hobart, IN
City:	Hobart, IN	GPS Northing:	2901609.519
Location:		GPS Easting:	2901609.519
Drain Area:	Northwest	GPS Accuracy:	Sub-Meter
Cover Shape:	Circular	Evidence of Surcharge:	No
Cover Size:	23.0	Potential for Runoff:	None
Comments:

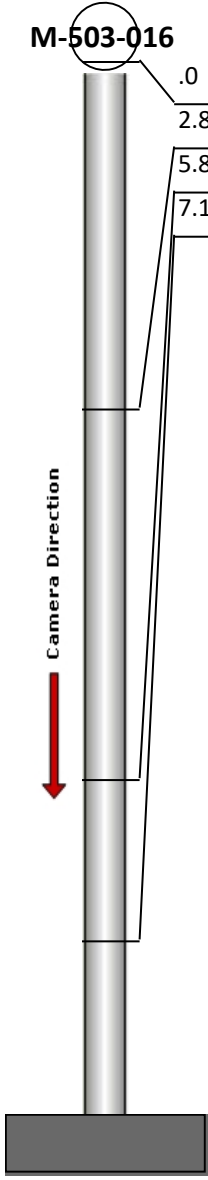
.0	MGP	General Photo	10	NA
	2.8	MGP	General Photo	29	NA
	5.8	DAZ	Deposits Attached Other	49	M 2
	7.1	MGO	General Observation	63	NA
