Manhole Inspection Report

Date:	04/09/2018	Weather:		Coding:	RZMACP
MH#:	M-503-018	Owner:	NA	Len. Surveyed:	5.3
P.O.#:		Surveyor:	John Kuglmaier	Rim to Invert:	6.3
Customer:		Cert. #:	U-1215-07002349	Wall Material:	Concrete (reinforced)

Street:	52' South of 39th Ave. 163' West of	Project:	Hobart, IN
City:	Hobart, IN	GPS Northing:	2901606.61
Location:		GPS Easting:	2901606.61
Drain Area:	Northwest	GPS Accuracy:	Sub-Meter
Cover Shape:	Circular	Evidence of Surcharge:	Yes
Cover Size:	23.0	Potential for Runoff:	None
Comments:

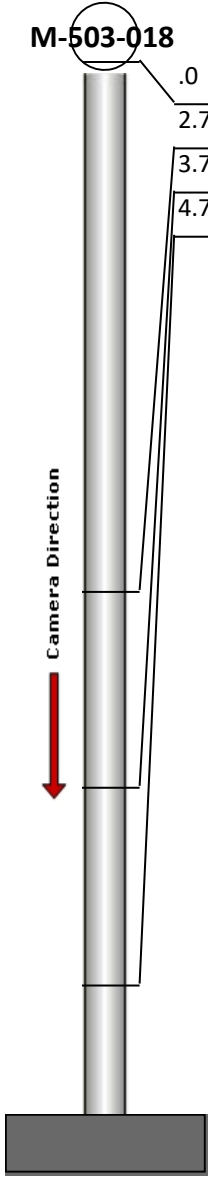
.0	MGP	General Photo	10	NA
	2.7	MGP	General Photo	29	NA
	3.7	MGO	General Observation	45	NA
	4.7	MGO	General Observation	58	NA
