Manhole Inspection Report

Date:	04/09/2018	Weather:		Coding:	RZMACP
MH#:	M-503-022	Owner:	NA	Len. Surveyed:	7.6
P.O.#:		Surveyor:	John Kuglmaier	Rim to Invert:	8.5
Customer:		Cert. #:	U-1215-07002349	Wall Material:	Concrete (reinforced)

Street:	173' West of Virginia St. 166' South	Project:	Hobart, IN
City:	Hobart, IN	GPS Northing:	2900871.082
Location:		GPS Easting:	2900871.082
Drain Area:	Northwest	GPS Accuracy:	Sub-Meter
Cover Shape:	Circular	Evidence of Surcharge:	Yes
Cover Size:	23.0	Potential for Runoff:	None
Comments:

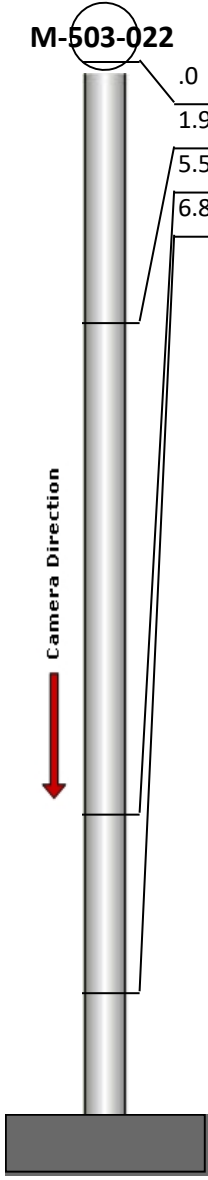
.0	MGP	General Photo	10	NA
	1.9	MGP	General Photo	27	NA
	5.5	DAZ	Deposits Attached Other	48	M 2
	6.8	MGO	General Observation	62	NA
