Manhole Inspection Report

Date:	04/09/2018	Weather:		Coding:	RZMACP
MH#:	M-503-027	Owner:	NA	Len. Surveyed:	6.6
P.O.#:		Surveyor:	John Kuglmaier	Rim to Invert:	7.3
Customer:		Cert. #:	U-1215-07002349	Wall Material:	Concrete (reinforced)

Street:	Intersection of 41st Ave and Virginia	Project:	Hobart, IN
City:	Hobart, IN	GPS Northing:	2900998.524
Location:		GPS Easting:	2900998.524
Drain Area:	Northwest	GPS Accuracy:	Sub-Meter
Cover Shape:	Circular	Evidence of Surcharge:	No
Cover Size:	23.0	Potential for Runoff:	None
Comments:

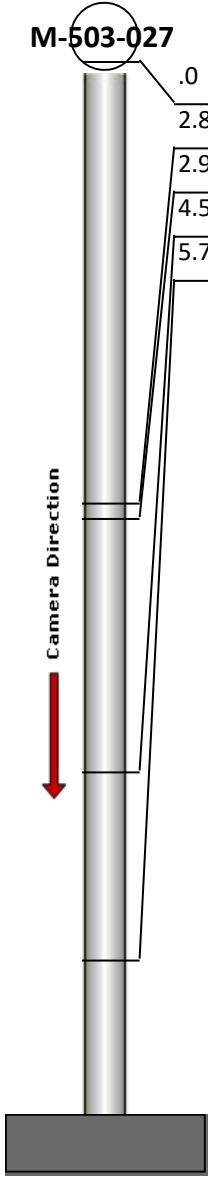
.0	MGP	General Photo	10	NA
	2.8	MGP	General Photo	29	NA
	2.9	IS	Infil Stain	44	NA
	4.5	DAZ	Deposits Attached Other	58	M 2
	5.7	MGO	General Observation	72	NA
