Manhole Inspection Report

Date:	04/10/2018	Weather:		Coding:	RZMACP
MH#:	M-503-035	Owner:	NA	Len. Surveyed:	1.9
P.O.#:		Surveyor:	John Kuglmaier	Rim to Invert:	2.7
Customer:		Cert. #:	U-1215-07002349	Wall Material:	Concrete (reinforced)

Street:	164' East of Cavender St. 271' North	Project:	Hobart, IN
City:	Hobart, IN	GPS Northing:	0.0
Location:		GPS Easting:	0.0
Drain Area:	Northwest	GPS Accuracy:	Nearest Meter
Cover Shape:	Circular	Evidence of Surcharge:	No
Cover Size:	23.0	Potential for Runoff:	None
Comments:

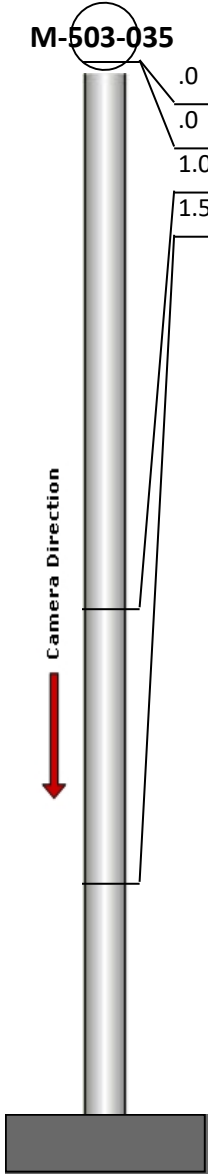
.0	MGP	General Photo	10	NA
	.0	DAZ	Deposits Attached Other	21	M 2
	1.0	IS	Infil Stain	35	NA
	1.5	MGO	General Observation	48	NA
