Manhole Inspection Report

| MH#: | M-503-057 | Owner: | NA | Len. Surveyed: | 10.9 |

| Street: | Colorado St. 170' South of 38th Ave. | Project: | Hobart, IN |

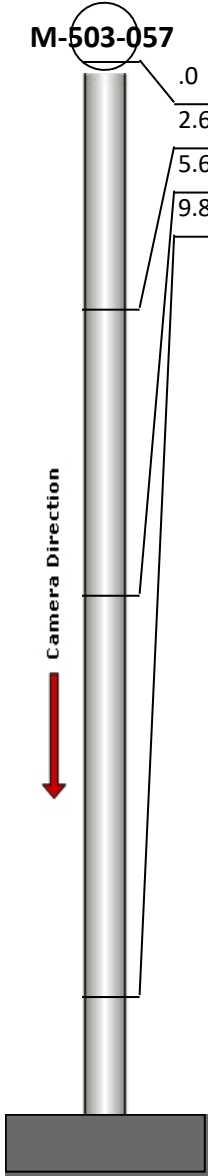
| | Position | Code | Observation | Video (sec) | Grade |
|---|---|---|---|---|---|
| | .0 | MGP | General Photo | 10 | NA |
| | 2.6 | MGP | General Photo | 29 | NA |
| | 5.6 | IS | Infil Stain | 49 | NA |
| | 9.8 | MGO | General Observation | 69 | NA |
