Manhole Inspection Report

Date:	03/30/2018	Weather:		Coding:	RZMACP
MH#:	M-503-072.1	Owner:	NA	Len. Surveyed:	7.1
P.O.#:		Surveyor:	John Kuglmaier	Rim to Invert:	8.2
Customer:		Cert. #:	U-1215-07002349	Wall Material:	Concrete (reinforced)

Street:	77' East of Virginia St. 287' North of	Project:	Hobart, IN
City:	Hobart, IN	GPS Northing:	0.0
Location:		GPS Easting:	0.0
Drain Area:	Northwest	GPS Accuracy:	Nearest Meter
Cover Shape:	Circular	Evidence of Surcharge:	Yes
Cover Size:	23.0	Potential for Runoff:	None
Comments:

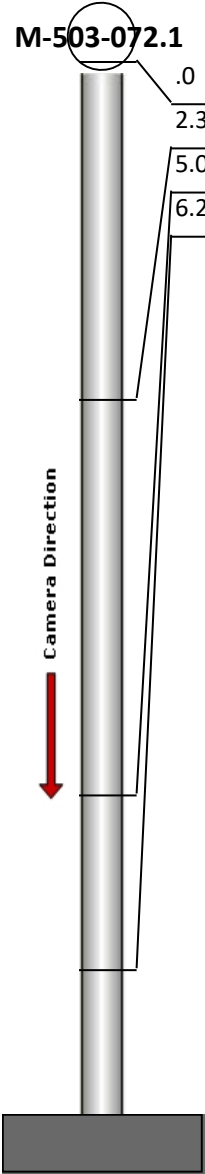
.0	MGP	General Photo	10	NA
	2.3	MGP	General Photo	28	NA
	5.0	DAZ	Deposits Attached Other	48	M 2
	6.2	MGO	General Observation	61	NA
