Manhole Inspection Report

Date:	03/30/2018	Weather:		Coding:	RZMACP
MH#:	M-503-073	Owner:	NA	Len. Surveyed:	13.9
P.O.#:		Surveyor:	John Kuglmaier	Rim to Invert:	16.4
Customer:		Cert. #:	U-1215-07002349	Wall Material:	Concrete (reinforced)

Street:	38th Ave. 260' West of Virginia St.	Project:	Hobart, IN
City:	Hobart, IN	GPS Northing:	0.0
Location:		GPS Easting:	0.0
Drain Area:	Northwest	GPS Accuracy:	Nearest Meter
Cover Shape:	Circular	Evidence of Surcharge:	Yes
Cover Size:	23.0	Potential for Runoff:	None
Comments:

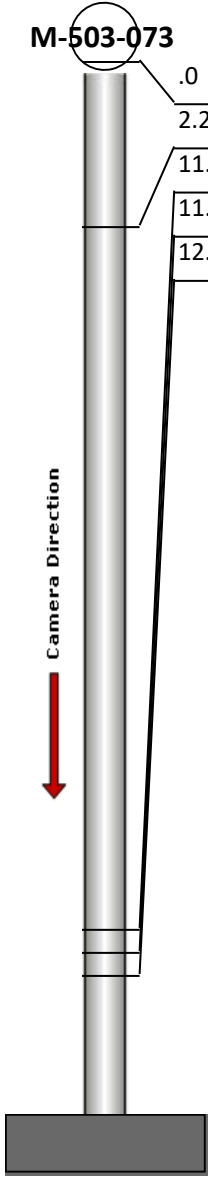
M-503-073				
	.0	MGP	General Photo	10	NA
	2.2	MGP	General Photo	28	NA
	11.6	DSF	Deposits Settled Fine	61	M 3
	11.9	IS	Infil Stain	73	NA
	12.2	MGO	General Observation	85	NA
