Manhole Inspection Report

Date:	03/30/2018	Weather:		Coding:	RZMACP
MH#:	M-503-078	Owner:	NA	Len. Surveyed:	7.1
P.O.#:		Surveyor:	John Kuglmaier	Rim to Invert:	8.7
Customer:		Cert. #:	U-1215-07002349	Wall Material:	Concrete (reinforced)

Street:	Colorado St. 165' North of 37th PL.	Project:	Hobart, IN
City:	Hobart, IN	GPS Northing:	0.0
Location:		GPS Easting:	0.0
Drain Area:	Northwest	GPS Accuracy:	Nearest Meter
Cover Shape:	Circular	Evidence of Surcharge:	Yes
Cover Size:	23.0	Potential for Runoff:	None
Comments:

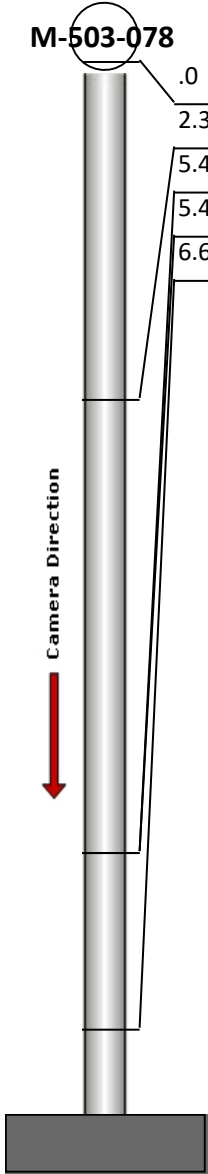
.0	MGP	General Photo	10	NA
	2.3	MGP	General Photo	28	NA
	5.4	DSF	Deposits Settled Fine	48	M 2
	5.4	IS	Infil Stain	60	NA
	6.6	MGO	General Observation	74	NA
