# Manhole Inspection Report

| MH#: | <b>M-504-003</b> | Owner: | <b>NA</b> | Len. Surveyed: | <b>10.6</b> |

| Street: | <b>Wisconsin St. and Home Ave. 1 to th</b> | Project: | <b>Hobart, IN</b> |

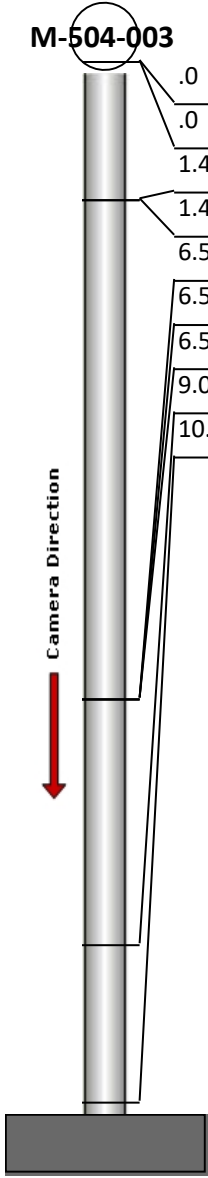
| | Position | Code | Observation | Video (sec) | Grade |
|--|---|---|---|---|---|
| | .0 | RFJ | Roots Fine Joint | 22 | M 1 |
| | 1.4 | DAE | Deposits Attached Encrustation | 51 | M 2 |
| | 6.5 | IS | Infil Stain | 72 | NA |
| | 6.5 | SAV | Surface Aggregate Visible | 95 | S 3 |
| | 9.0 | DSC | Deposits Settled Compacted | 111 | M 2 |
