Manhole Inspection Report

Date:	05/14/2018	Weather:		Coding:	RZMACP
MH#:	M-504-011	Owner:	NA	Len. Surveyed:	8.7
P.O.#:		Surveyor:	Jen Costello	Rim to Invert:	9.2
Customer:		Cert. #:	U-907-5518	Wall Material:	Brick

Street:	44th Ave. 318' East of Delaware St.	Project:	Hobart, IN
City:	Hobart, IN	GPS Northing:	41.53824615
Location:		GPS Easting:	-87.27183533
Drain Area:	West	GPS Accuracy:	Nearest Meter
Cover Shape:	Circular	Evidence of Surcharge:	No
Cover Size:	22.5	Potential for Runoff:	None
Comments:

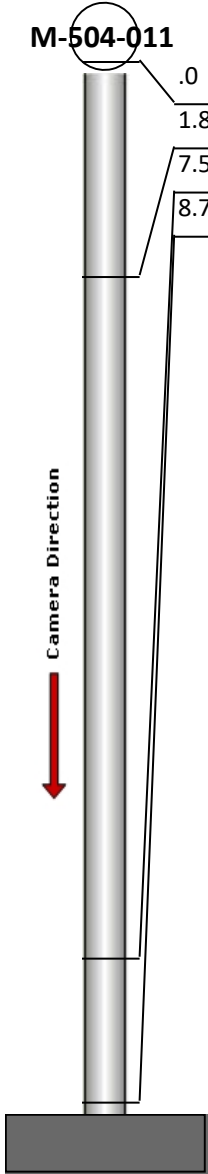
.0	MGO	General Observation	10	NA
	1.8	MGO	General Observation	27	NA
	7.5	OBZ	Obstacle Other	52	M 2
	8.7	MGO	General Observation	66	NA
