Manhole Inspection Report

Date:	05/14/2018	Weather:		Coding:	RZMACP
MH#:	M-504-012	Owner:	NA	Len. Surveyed:	9.8
P.O.#:		Surveyor:	Jen Costello	Rim to Invert:	10.0
Customer:		Cert. #:	U-907-5518	Wall Material:	Brick

Street:	162' North of 44th Ave. East of Dela	Project:	Hobart, IN
City:	Hobart, IN	GPS Northing:	41.53862762
Location:		GPS Easting:	-87.27186584
Drain Area:	West	GPS Accuracy:	Nearest Meter
Cover Shape:	Circular	Evidence of Surcharge:	No
Cover Size:	22.5	Potential for Runoff:	None
Comments:

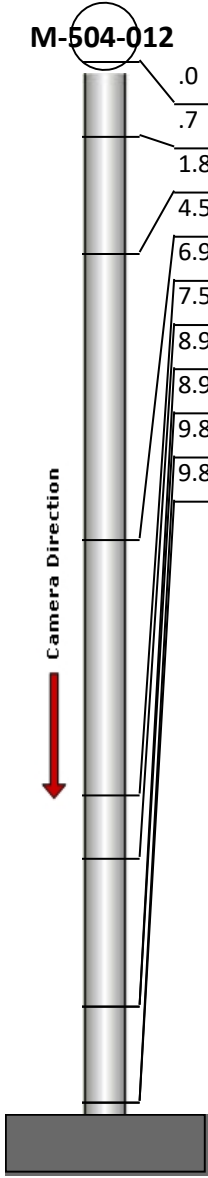
M-504-012				
	.0	MGO	General Observation	10	NA
	.7	SAV	Surface Aggregate Visible	22	S 3
	1.8	MGO	General Observation	37	NA
	4.5	DAR	Deposits Attached Ragging	55	M 2
	6.9	DAR	Deposits Attached Ragging	72	M 2
	7.5	HVV	Hole Void Visible	85	S 5
	8.9	OBM	Obstacle Pipe Material	99	M 2
	8.9	DAGS	Deposits Attached Grease	110	M 2
	9.8	MGO	General Observation	124	NA
	9.8	SAV	Surface Aggregate Visible	135	S 3
