Manhole Inspection Report

Date:	05/13/2018	Weather:		Coding:	RZMACP
MH#:	M-504-025	Owner:	NA	Len. Surveyed:	14.4
P.O.#:		Surveyor:	Jen Costello	Rim to Invert:	14.0
Customer:		Cert. #:	U-907-5518	Wall Material:	Concrete (reinforced)

Street:	45th Ave. 229' West of Colorado St.	Project:	Hobart, IN
City:	Hobart, IN	GPS Northing:	41.53644562
Location:		GPS Easting:	-87.27500153
Drain Area:	West	GPS Accuracy:	Nearest Meter
Cover Shape:	Circular	Evidence of Surcharge:	No
Cover Size:	22.5	Potential for Runoff:	None
Comments:

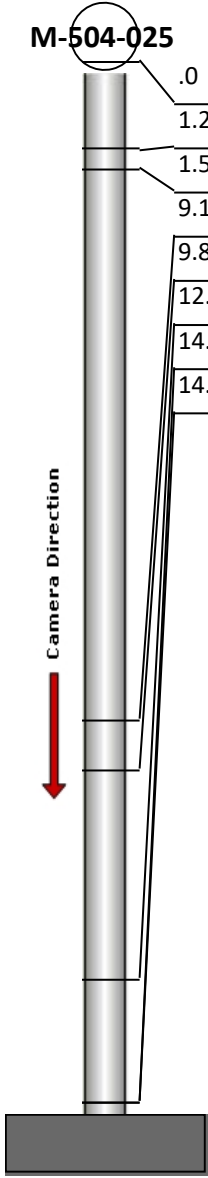
.0	MGO	General Observation	10	NA
	1.2	SAV	Surface Aggregate Visible	23	S 3
	1.5	MGO	General Observation	37	NA
	9.1	DAR	Deposits Attached Ragging	65	M 2
	9.8	MGO	General Observation	78	NA
	12.7	DSF	Deposits Settled Fine	96	M 2
	14.4	MGO	General Observation	111	NA
	14.4	SAV	Surface Aggregate Visible	122	S 3
