# Manhole Inspection Report

Date:	<b>05/14/2018</b>	Weather:		Coding:	<b>RZMACP</b>
MH#:	<b>M-504-061</b>	Owner:	<b>NA</b>	Len. Surveyed:	<b>6.1</b>
P.O.#:		Surveyor:	<b>Jen Costello</b>	Rim to Invert:	<b>6.2</b>
Customer:		Cert. #:	<b>U-907-5518</b>	Wall Material:	<b>Brick</b>

Street:	<b>Ridge Rd. 31' West of California St.</b>	Project:	<b>Hobart, IN</b>
City:	<b>Hobart, IN</b>	GPS Northing:	<b>41.54027176</b>
Location:		GPS Easting:	<b>-87.27709961</b>
Drain Area:	<b>Northwest</b>	GPS Accuracy:	<b>Nearest Meter</b>
Cover Shape:	<b>Circular</b>	Evidence of Surcharge:	<b>No</b>
Cover Size:	<b>22.5</b>	Potential for Runoff:	<b>None</b>
Comments:

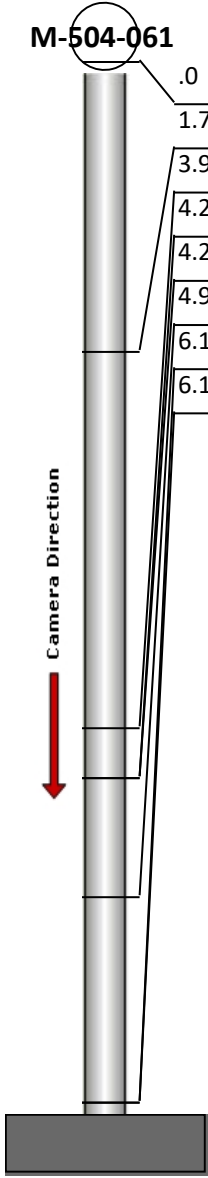
.0	MGO	General Observation	10	NA
	1.7	MGO	General Observation	27	NA
	3.9	RPP	Repair Patch	45	NA
	4.2	FS	Fracture Spiral	57	S 3
	4.2	IW	Infil Weeper	69	M 2
	4.9	DSF	Deposits Settled Fine	82	M 2
	6.1	SAP	Surface Aggregate Projecting	96	S 3
	6.1	MGO	General Observation	107	NA
