Manhole Inspection Report

Date:	05/15/2018	Weather:		Coding:	RZMACP
MH#:	M-504-103	Owner:	NA	Len. Surveyed:	11.6
P.O.#:		Surveyor:	Jen Costello	Rim to Invert:	12.2
Customer:		Cert. #:	U-907-5518	Wall Material:	Concrete (reinforced)

Street:	Delaware St. and Colorado St. South	Project:	Hobart, IN
City:	Hobart, IN	GPS Northing:	41.54092789
Location:		GPS Easting:	-87.27407837
Drain Area:	Northwest	GPS Accuracy:	Nearest Meter
Cover Shape:	Circular	Evidence of Surcharge:	No
Cover Size:	22.5	Potential for Runoff:	None
Comments:

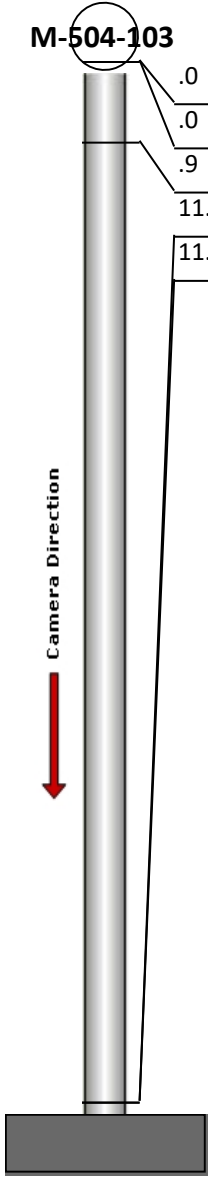
Position	Code	Observation	Video (sec)	Grade

.0	MGO	General Observation	10	NA
	.0	DAE	Deposits Attached Encrustation	21	M 2
	.9	IW	Infil Weeper	35	M 2
	11.6	DSF	Deposits Settled Fine	67	M 2
	11.6	MGO	General Observation	78	NA
