# Manhole Inspection Report

Date:	<b>05/15/2018</b>	Weather:		Coding:	<b>RZMACP</b>
MH#:	<b>M-504-104</b>	Owner:	<b>NA</b>	Len. Surveyed:	<b>10.6</b>
P.O.#:		Surveyor:	<b>Jen Costello</b>	Rim to Invert:	<b>11.2</b>
Customer:		Cert. #:	<b>U-907-5518</b>	Wall Material:	<b>Brick</b>

Street:	<b>159' East of Colorado St. 133' South</b>	Project:	<b>Hobart, IN</b>
City:	<b>Hobart, IN</b>	GPS Northing:	<b>41.54148865</b>
Location:		GPS Easting:	<b>-87.27415466</b>
Drain Area:	<b>Northwest</b>	GPS Accuracy:	<b>Nearest Meter</b>
Cover Shape:	<b>Circular</b>	Evidence of Surcharge:	<b>No</b>
Cover Size:	<b>22.5</b>	Potential for Runoff:	<b>None</b>
Comments:

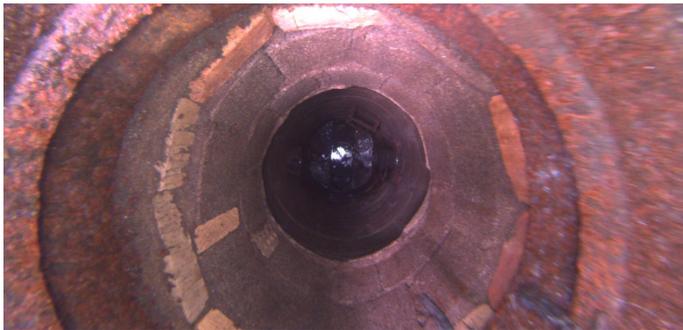
Code: **MGO**  
Description: **General Observation**

Distance (ft): **.0**  
Structural Grade: **0**  
O&M Grade: **0**  
Clock Start/From:  
Clock To:  
1st Value:  
2nd Value:  
Value Percent:  
Step: **NO**  
Remarks: **ACCESS MH**

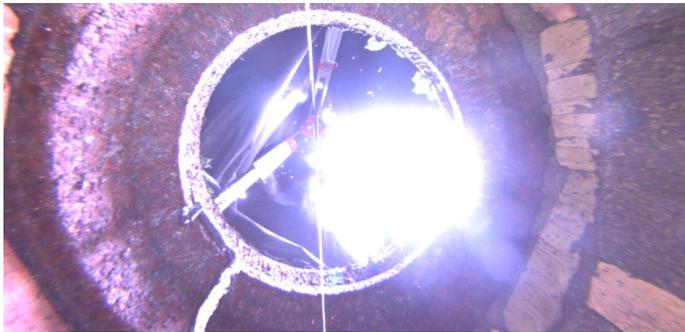
Code: **MGO**  
Description: **General Observation**

Distance (ft): **2.4**  
Structural Grade: **0**  
O&M Grade: **0**  
Clock Start/From:  
Clock To:  
1st Value:  
2nd Value:  
Value Percent:  
Step: **NO**  
Remarks: **UNDERSIDE OF FRAME**

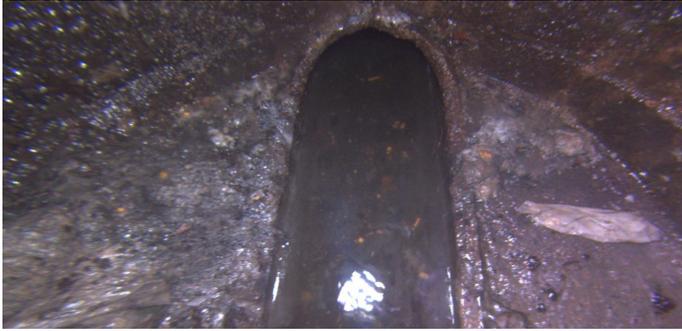
Code: **MGO**  
Description: **General Observation**

Distance (ft): **10.6**  
Structural Grade: **0**  
O&M Grade: **0**  
Clock Start/From:  
Clock To:  
1st Value:  
2nd Value:  
Value Percent:  
Step: **NO**  
Remarks: **END SURVEY**
