Manhole Inspection Report

Date:	05/15/2018	Weather:		Coding:	RZMACP
MH#:	M-504-106	Owner:	NA	Len. Surveyed:	7.4
P.O.#:		Surveyor:	Jen Costello	Rim to Invert:	8.2
Customer:		Cert. #:	U-907-5518	Wall Material:	Brick

Street:	162' West of Virginia St. 215' South	Project:	Hobart, IN
City:	Hobart, IN	GPS Northing:	41.46604156
Location:		GPS Easting:	-87.32584381
Drain Area:	Northwest	GPS Accuracy:	Nearest Meter
Cover Shape:	Circular	Evidence of Surcharge:	No
Cover Size:	22.5	Potential for Runoff:	None
Comments:

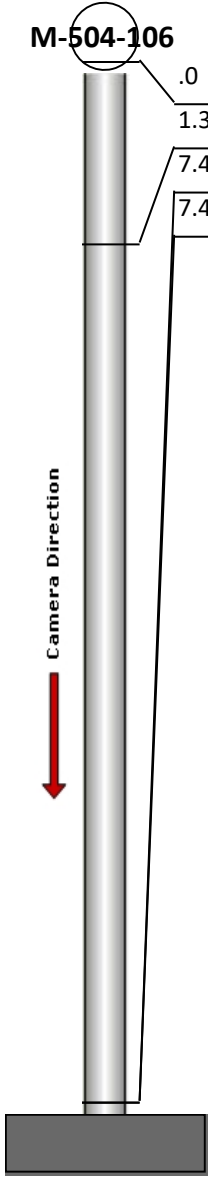
.0	MGO	General Observation	10	NA
	1.3	MGO	General Observation	25	NA
	7.4	DSF	Deposits Settled Fine	51	M 2
	7.4	MGO	General Observation	62	NA
