Manhole Inspection Report

Date:	04/10/2018	Weather:		Coding:	RZMACP
MH#:	M-504-110	Owner:	NA	Len. Surveyed:	4.2
P.O.#:		Surveyor:	John Kuglmaier	Rim to Invert:	5.3
Customer:		Cert. #:	U-1215-07002349	Wall Material:	Concrete (reinforced)

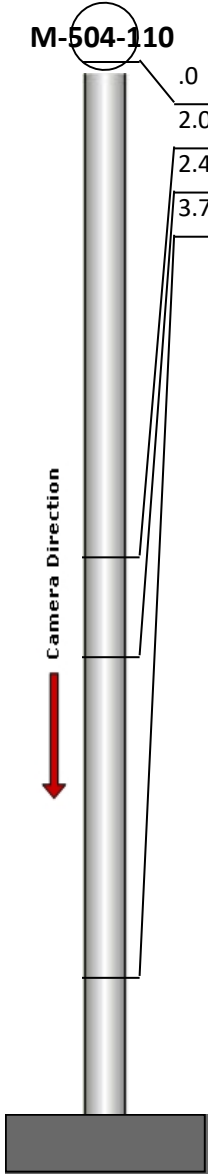
.0	MGP	General Photo	10	NA
	2.0	MGP	General Photo	28	NA
	2.4	DAZ	Deposits Attached Other	42	M 2
	3.7	MGO	General Observation	56	NA
