Manhole Inspection Report

Date:	04/10/2018	Weather:		Coding:	RZMACP
MH#:	M-504-128	Owner:	NA	Len. Surveyed:	4.2
P.O.#:		Surveyor:	John Kuglmaier	Rim to Invert:	5.1
Customer:		Cert. #:	U-1215-07002349	Wall Material:	Concrete (reinforced)

Street:	41st Ave. 165' East of Wilson St.	Project:	Hobart, IN
City:	Hobart, IN	GPS Northing:	2899536.924
Location:		GPS Easting:	2899536.924
Drain Area:	Northwest	GPS Accuracy:	Sub-Meter
Cover Shape:	Circular	Evidence of Surcharge:	Yes
Cover Size:	23.0	Potential for Runoff:	None
Comments:

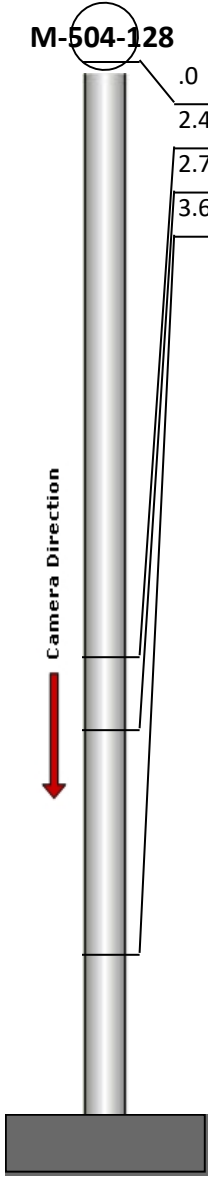
.0	MGP	General Photo	10	NA
	2.4	MGP	General Photo	29	NA
	2.7	DAZ	Deposits Attached Other	43	M 3
	3.6	MGO	General Observation	56	NA
