Manhole Inspection Report

Date:	05/14/2018	Weather:		Coding:	RZMACP
MH#:	M-504-131	Owner:	NA	Len. Surveyed:	3.6
P.O.#:		Surveyor:	Jen Costello	Rim to Invert:	3.4
Customer:		Cert. #:	U-907-5518	Wall Material:	Concrete (reinforced)

Street:	Alley Behind Wiseway. East Side. 24	Project:	Hobart, IN
City:	Hobart, IN	GPS Northing:	41.53866196
Location:		GPS Easting:	-87.39647675
Drain Area:	West	GPS Accuracy:	Nearest Meter
Cover Shape:	Circular	Evidence of Surcharge:	No
Cover Size:	22.5	Potential for Runoff:	None
Comments:

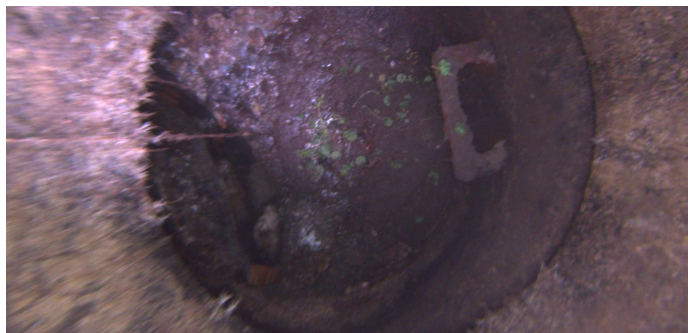
Code: **MGO**
Description: **General Observation**

Distance (ft): **.0**
Structural Grade: **0**
O&M Grade: **0**
Clock Start/From:
Clock To:
1st Value:
2nd Value:
Value Percent:
Step: **NO**
Remarks: **access MH**

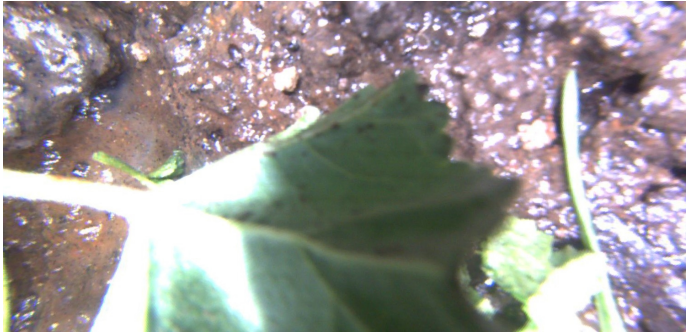
Code:	MGO
Description:	General Observation
Distance (ft):	3.6
Structural Grade:	0
O&M Grade:	0
Clock Start/From:	
Clock To:	
1st Value:	
2nd Value:	
Value Percent:	
Step:	NO
Remarks:	END SURVEY
