Manhole Inspection Report

Date:	05/02/2018	Weather:		Coding:	RZMACP
MH#:	M-505-002	Owner:	NA	Len. Surveyed:	10.4
P.O.#:		Surveyor:	Jen Costello	Rim to Invert:	10.4
Customer:		Cert. #:	U-907-5518	Wall Material:	Concrete (reinforced)

Street:	Intersection of Wisconsin St. and 3r	Project:	Hobart, IN
City:	Hobart, IN	GPS Northing:	41.5326767
Location:		GPS Easting:	-87.26937103
Drain Area:	West	GPS Accuracy:	Nearest Meter
Cover Shape:	Circular	Evidence of Surcharge:	No
Cover Size:	22.5	Potential for Runoff:	None
Comments:

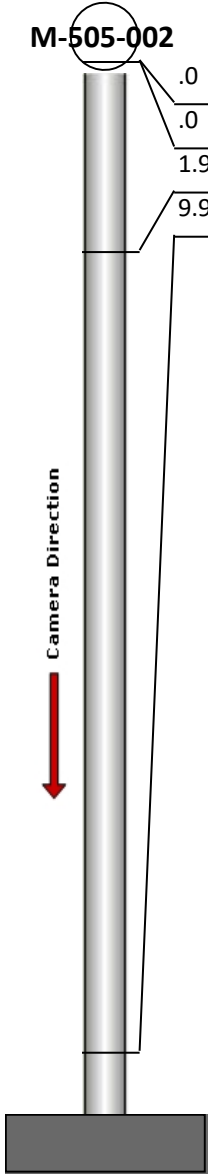
M-505-002				
	.0	MGP	General Photo	10	NA
	.0	DAE	Deposits Attached Encrustation	21	M 2
	1.9	MGO	General Observation	39	NA
	9.9	MGO	General Observation	68	NA
