Manhole Inspection Report

Date:	04/30/2018	Weather:		Coding:	RZMACP
MH#:	M-505-014	Owner:	NA	Len. Surveyed:	13.2
P.O.#:		Surveyor:	Jen Costello	Rim to Invert:	14.2
Customer:		Cert. #:	U-907-5518	Wall Material:	Concrete (reinforced)

Street:	Intersection of W. 3rd Pl. and Virgini	Project:	Hobart, IN
City:	Hobart, IN	GPS Northing:	2901133.302
Location:		GPS Easting:	2901133.302
Drain Area:	West	GPS Accuracy:	Sub-Meter
Cover Shape:	Circular	Evidence of Surcharge:	No
Cover Size:	22.5	Potential for Runoff:	None
Comments:

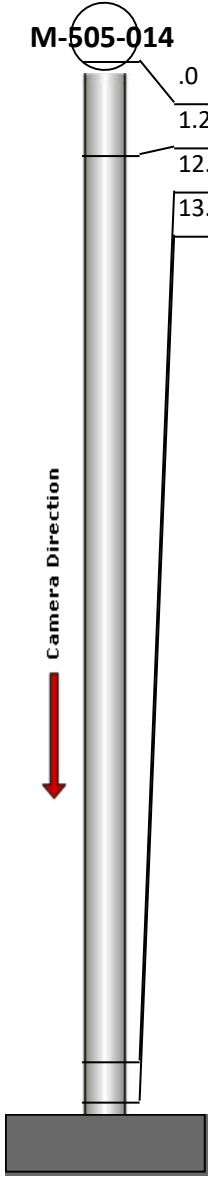
M-505-014				
	.0	MGO	General Observation	10	NA
	1.2	MGO	General Observation	26	NA
	12.7	SAP	Surface Aggregate Projecting	62	S 3
	13.2	MGO	General Observation	75	NA
