Manhole Inspection Report

Date:	05/14/2018	Weather:		Coding:	RZMACP
MH#:	M-505-043	Owner:	NA	Len. Surveyed:	12.2
P.O.#:		Surveyor:	Jen Costello	Rim to Invert:	13.8
Customer:		Cert. #:	U-907-5518	Wall Material:	Concrete (reinforced)

Street:	Intersection of Virginia St. and 2nd S	Project:	Hobart, IN
City:	Hobart, IN	GPS Northing:	41.53455734
Location:		GPS Easting:	-87.27170563
Drain Area:	West	GPS Accuracy:	Nearest Meter
Cover Shape:	Circular	Evidence of Surcharge:	No
Cover Size:	22.5	Potential for Runoff:	None
Comments:

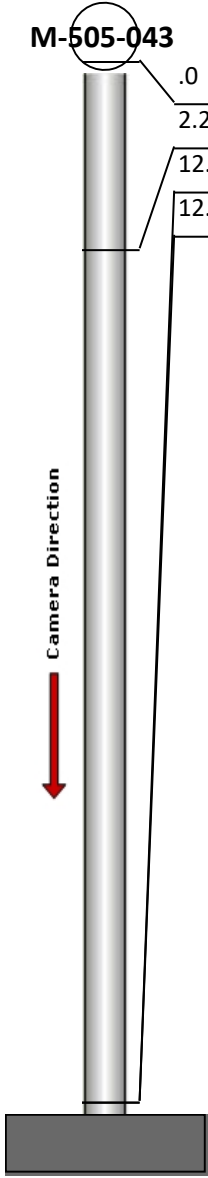
M-505-043				
	.0	MGO	General Observation	10	NA
	2.2	MGO	General Observation	28	NA
	12.2	DAGS	Deposits Attached Grease	62	M 2
	12.2	MGO	General Observation	73	NA
