Manhole Inspection Report

Date:	05/14/2018	Weather:		Coding:	RZMACP
MH#:	M-505-050	Owner:	NA	Len. Surveyed:	7.3
P.O.#:		Surveyor:	Jen Costello	Rim to Invert:	8.7
Customer:		Cert. #:	U-907-5518	Wall Material:	Concrete (reinforced)

Street:	Delaware St. North of 2nd St.	Project:	Hobart, IN
City:	Hobart, IN	GPS Northing:	41.53547287
Location:		GPS Easting:	-87.2729187
Drain Area:	West	GPS Accuracy:	Nearest Meter
Cover Shape:	Circular	Evidence of Surcharge:	No
Cover Size:	22.5	Potential for Runoff:	None
Comments:

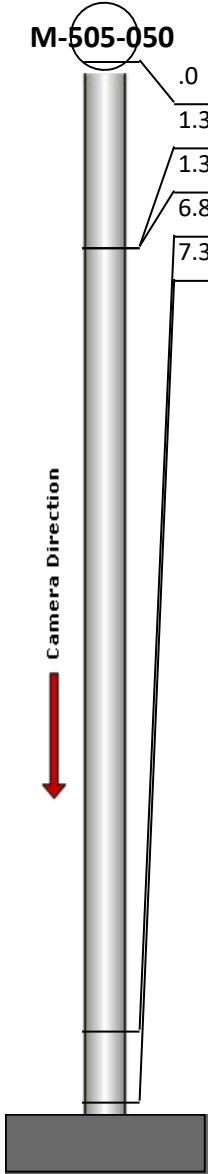
.0	MGO	General Observation	10	NA
	1.3	MGO	General Observation	26	NA
	1.3	IS	Infil Stain	38	NA
	6.8	DSGV	Deposits Settled Gravel	60	M 2
	7.3	MGO	General Observation	72	NA
