Manhole Inspection Report

Date:	05/01/2018	Weather:		Coding:	RZMACP
MH#:	M-505-053.1	Owner:	NA	Len. Surveyed:	3.4
P.O.#:		Surveyor:	Jen Costello	Rim to Invert:	3.4
Customer:		Cert. #:	U-907-5518	Wall Material:	Concrete (reinforced)

Street:	Colorado St. 397' South of 2nd St.	Project:	Hobart, IN
City:	Hobart, IN	GPS Northing:	41.53353119
Location:		GPS Easting:	-87.27409363
Drain Area:	West	GPS Accuracy:	Nearest Meter
Cover Shape:	Circular	Evidence of Surcharge:	No
Cover Size:	22.5	Potential for Runoff:	None
Comments:

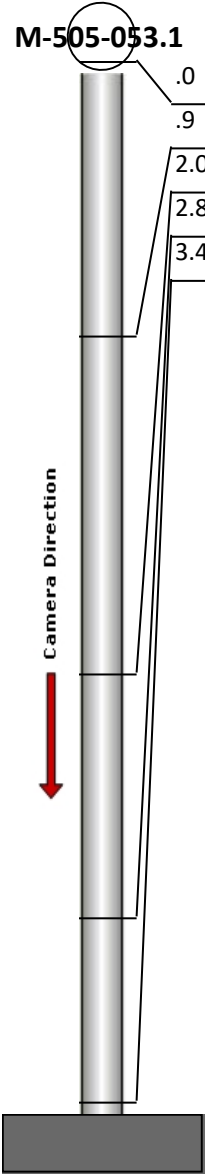
Position	Code	Observation	Video (sec)	Grade
M-505-053.1

.0	MGO	General Observation	10	NA
	.9	FM	Fracture Multiple	23	S 4
	2.0	B	Broken	37	S 4
	2.8	DSF	Deposits Settled Fine	49	M 2
	3.4	MGO	General Observation	61	NA
