Manhole Inspection Report

Date:	04/28/2018	Weather:		Coding:	RZMACP
MH#:	M-505-081	Owner:	NA	Len. Surveyed:	6.3
P.O.#:		Surveyor:	Jen Costello	Rim to Invert:	7.2
Customer:		Cert. #:	U-907-5518	Wall Material:	Concrete (reinforced)

Street:	4th St. 715' East of Wabash St.	Project:	Hobart, IN
City:	Hobart, IN	GPS Northing:	2899794.847
Location:		GPS Easting:	2899794.847
Drain Area:	West	GPS Accuracy:	Sub-Meter
Cover Shape:	Circular	Evidence of Surcharge:	No
Cover Size:	22.5	Potential for Runoff:	None
Comments:

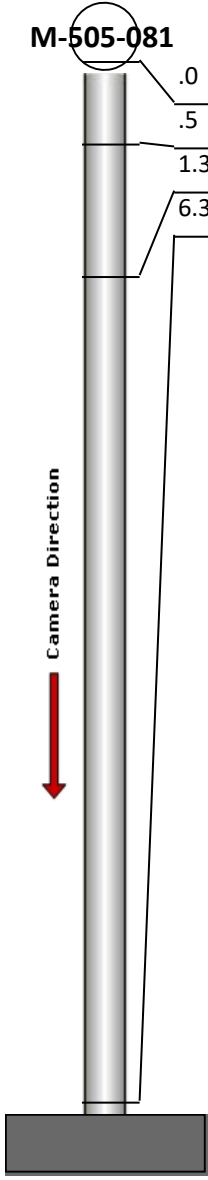
.0	MGO	General Observation	10	NA
	.5	DAE	Deposits Attached Encrustation	23	M 2
	1.3	MGP	General Photo	38	NA
	6.3	MGO	General Observation	61	NA
