Manhole Inspection Report

Date:	09/27/2022	Weather:		Coding:	RZMACP
MH#:	M-505-084	Owner:	NA	Len. Surveyed:	7.7
P.O.#:		Surveyor:	Jen Costello	Rim to Invert:	8.4
Customer:		Cert. #:	U-907-5518	Wall Material:	Concrete (cast in place)

Street:	4th Pl. 6 Manholes East of Liftstatio	Project:	Hobart, IN
City:	Hobart, IN	GPS Northing:	2287959.199
Location:	Local Rural Streets	GPS Easting:	2900517.943
Drain Area:	West	GPS Accuracy:	Sub-Meter
Cover Shape:	Circular	Evidence of Surcharge:	No
Cover Size:	24.0	Potential for Runoff:	None
Comments:

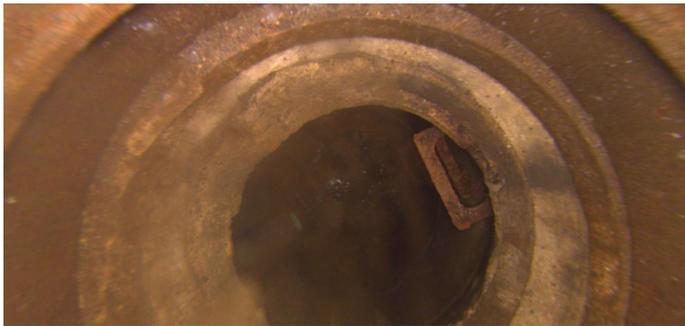
Code: **MGO**
Description: **General Observation**

Distance (ft): **.0**
Structural Grade: **0**
O&M Grade: **0**
Clock Start/From:
Clock To:
1st Value:
2nd Value:
Value Percent:
Step: **NO**
Remarks: **access mh**

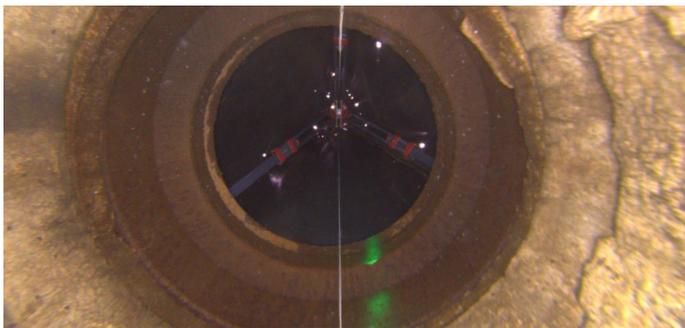
Code: **MGO**
Description: **General Observation**

Distance (ft): **2.5**
Structural Grade: **0**
O&M Grade: **0**
Clock Start/From:
Clock To:
1st Value:
2nd Value:
Value Percent:
Step: **NO**
Remarks: **underside of frame**

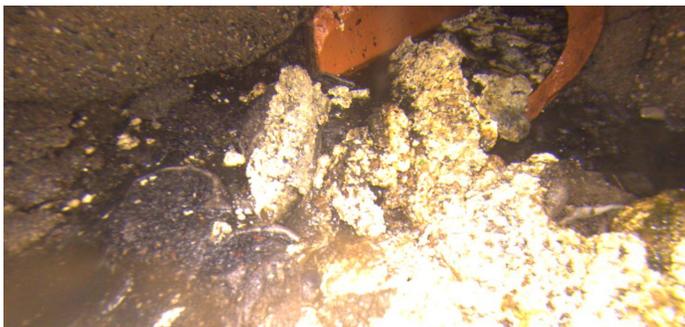
Code: **MGO**
Description: **General Observation**

Distance (ft): **7.7**
Structural Grade: **0**
O&M Grade: **0**
Clock Start/From:
Clock To:
1st Value:
2nd Value:
Value Percent:
Step: **NO**
Remarks: **end of survey**
