Manhole Inspection Report

Date:	04/28/2018	Weather:		Coding:	RZMACP
MH#:	M-505-086	Owner:	NA	Len. Surveyed:	10.7
P.O.#:		Surveyor:	Jen Costello	Rim to Invert:	11.2
Customer:		Cert. #:	U-907-5518	Wall Material:	Concrete (reinforced)

Street:	4th Pl. 4 Manholes East of Liftstatio	Project:	Hobart, IN
City:	Hobart, IN	GPS Northing:	2900073.066
Location:		GPS Easting:	2900073.066
Drain Area:	West	GPS Accuracy:	Sub-Meter
Cover Shape:	Circular	Evidence of Surcharge:	No
Cover Size:	22.5	Potential for Runoff:	None
Comments:

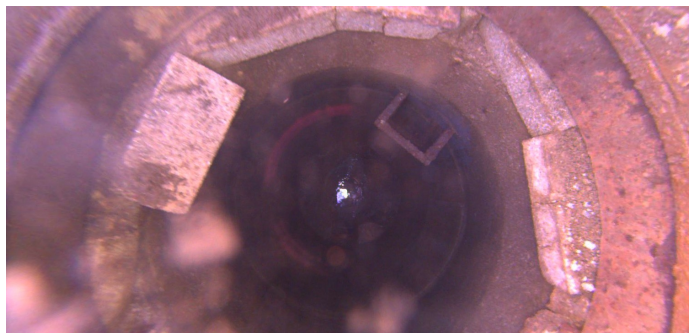
Code: **MGO**
Description: **General Observation**

Distance (ft): **.0**
Structural Grade: **0**
O&M Grade: **0**
Clock Start/From:
Clock To:
1st Value:
2nd Value:
Value Percent:
Step: **NO**
Remarks: **ACCESS MH**

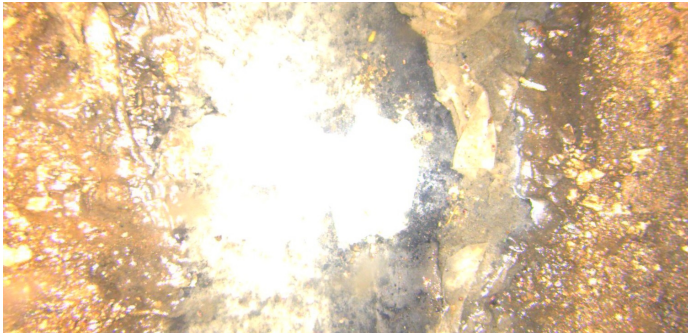
Code: **MGO**
Description: **General Observation**

Distance (ft): **10.7**
Structural Grade: **0**
O&M Grade: **0**
Clock Start/From:
Clock To:
1st Value:
2nd Value:
Value Percent:
Step: **NO**
Remarks: **END SURVEY**
