Manhole Inspection Report

Date:	04/24/2018	Weather:		Coding:	RZMACP
MH#:	M-505-087	Owner:	NA	Len. Surveyed:	12.7
P.O.#:		Surveyor:	John Kuglmaier	Rim to Invert:	12.1
Customer:		Cert. #:	U-1215-07002349	Wall Material:	Concrete (reinforced)

Street:	4th Pl. 3 Manholes East of Liftstatio	Project:	Hobart, IN
City:	Hobart, IN	GPS Northing:	2899827.711
Location:		GPS Easting:	2899827.711
Drain Area:	West	GPS Accuracy:	Sub-Meter
Cover Shape:	Circular	Evidence of Surcharge:	Yes
Cover Size:	22.5	Potential for Runoff:	None
Comments:

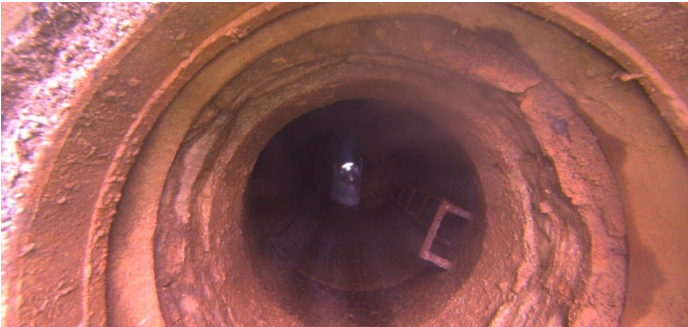
Code:

MGP

Description:

General Photo

Distance (ft):

.0

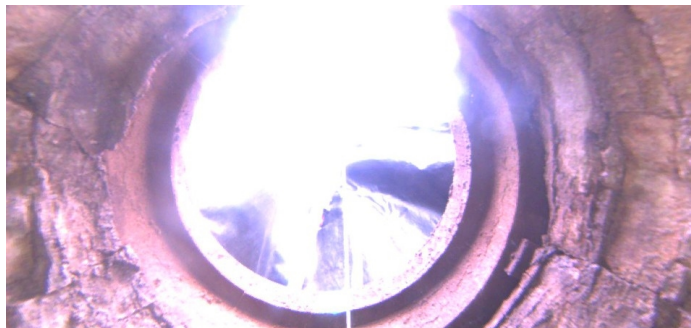
Code: **MGP**
Description: **General Photo**

Distance (ft): **2.5**
Structural Grade: **0**
O&M Grade: **0**
Clock Start/From:
Clock To:
1st Value:
2nd Value:
Value Percent:
Step: **NO**
Remarks:
