Manhole Inspection Report

Date:	04/28/2018	Weather:		Coding:	RZMACP
MH#:	M-505-097	Owner:	NA	Len. Surveyed:	7.5
P.O.#:		Surveyor:	Jen Costello	Rim to Invert:	7.7
Customer:		Cert. #:	U-907-5518	Wall Material:	Concrete (reinforced)

Street:	4th St. 1145' East of Wabash St.	Project:	Hobart, IN
City:	Hobart, IN	GPS Northing:	2900223.007
Location:		GPS Easting:	2900223.007
Drain Area:	West	GPS Accuracy:	Sub-Meter
Cover Shape:	Circular	Evidence of Surcharge:	No
Cover Size:	22.5	Potential for Runoff:	None
Comments:

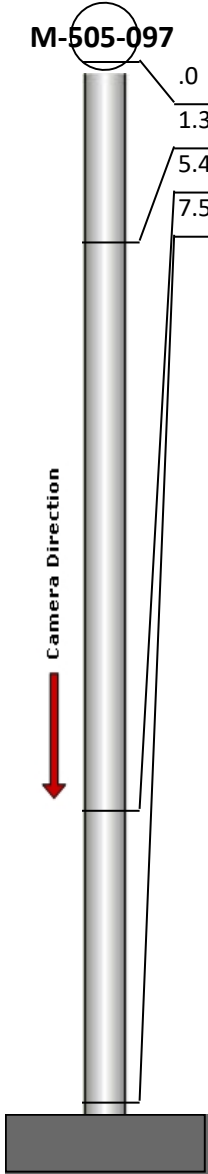
.0	MGO	General Observation	10	NA
	1.3	MGP	General Photo	26	NA
	5.4	OBM	Obstacle Pipe Material	47	M 2
	7.5	MGO	General Observation	63	NA
