Manhole Inspection Report

Date:	04/24/2018	Weather:		Coding:	RZMACP
MH#:	M-506-009	Owner:	NA	Len. Surveyed:	7.0
P.O.#:		Surveyor:	John Kuglmaier	Rim to Invert:	6.8
Customer:		Cert. #:	U-1215-07002349	Wall Material:	Concrete (reinforced)

Street:	Cardinal Ct. 435' South of 8th St.	Project:	Hobart, IN
City:	Hobart, IN	GPS Northing:	2900348.302
Location:		GPS Easting:	2900348.302
Drain Area:	Southwest	GPS Accuracy:	Sub-Meter
Cover Shape:	Circular	Evidence of Surcharge:	No
Cover Size:	22.5	Potential for Runoff:	None
Comments:

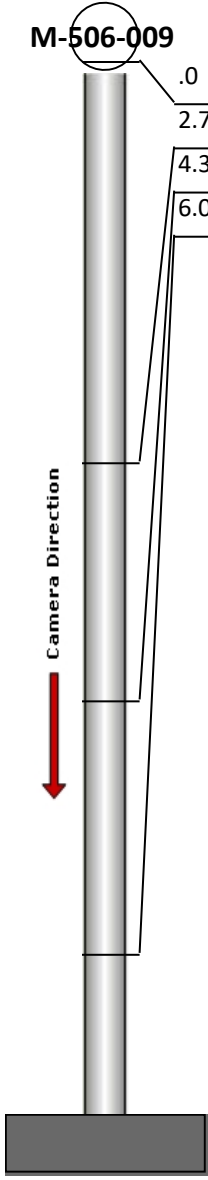
.0	MGP	General Photo	10	NA
	2.7	MGP	General Photo	29	NA
	4.3	DAZ	Deposits Attached Other	46	M 2
	6.0	MGO	General Observation	61	NA
