Manhole Inspection Report

Date:	04/24/2018	Weather:		Coding:	RZMACP
MH#:	M-506-022	Owner:	NA	Len. Surveyed:	8.8
P.O.#:		Surveyor:	John Kuglmaier	Rim to Invert:	8.9
Customer:		Cert. #:	U-1215-07002349	Wall Material:	Concrete (reinforced)

Street:	Intersection of River Terrace and 8th	Project:	Hobart, IN
City:	Hobart, IN	GPS Northing:	2900192.793
Location:		GPS Easting:	2900192.793
Drain Area:	Southwest	GPS Accuracy:	Sub-Meter
Cover Shape:	Circular	Evidence of Surcharge:	No
Cover Size:	22.5	Potential for Runoff:	None
Comments:

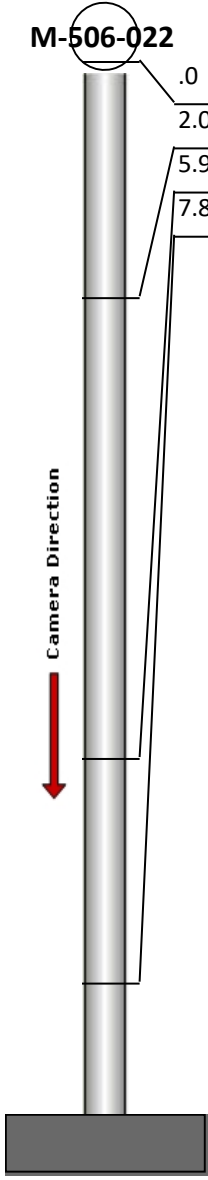
M-506-022				
	.0	MGP	General Photo	10	NA
	2.0	MGP	General Photo	28	NA
	5.9	DAZ	Deposits Attached Other	49	M 2
	7.8	MGO	General Observation	64	NA
