Manhole Inspection Report

Date:	04/24/2018	Weather:		Coding:	RZMACP
MH#:	M-506-023	Owner:	NA	Len. Surveyed:	12.1
P.O.#:		Surveyor:	John Kuglmaier	Rim to Invert:	12.4
Customer:		Cert. #:	U-1215-07002349	Wall Material:	Concrete (reinforced)

Street:	North of 8th St. 188' West of Colora	Project:	Hobart, IN
City:	Hobart, IN	GPS Northing:	2900357.503
Location:		GPS Easting:	2900357.503
Drain Area:	Southwest	GPS Accuracy:	Sub-Meter
Cover Shape:	Circular	Evidence of Surcharge:	No
Cover Size:	22.5	Potential for Runoff:	None
Comments:

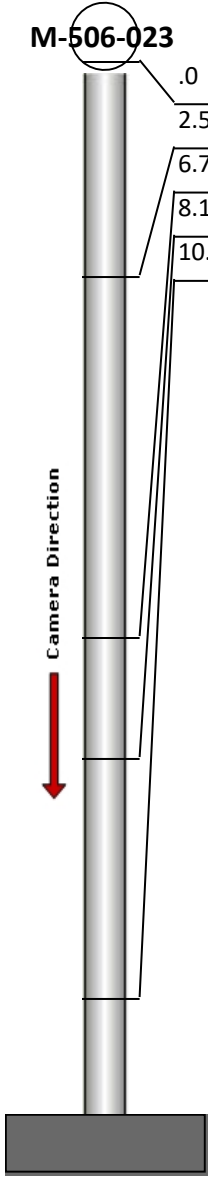
.0	MGP	General Photo	10	NA
	2.5	MGP	General Photo	29	NA
	6.7	IS	Infil Stain	51	NA
	8.1	IS	Infil Stain	66	NA
	10.9	MGO	General Observation	83	NA
