Manhole Inspection Report

Date:	04/24/2018	Weather:		Coding:	RZMACP
MH#:	M-506-026	Owner:	NA	Len. Surveyed:	4.4
P.O.#:		Surveyor:	John Kuglmaier	Rim to Invert:	4.1
Customer:		Cert. #:	U-1215-07002349	Wall Material:	Concrete (reinforced)

Street:	Colorado St. 74' North of 7th Pl.	Project:	Hobart, IN
City:	Hobart, IN	GPS Northing:	2900541.392
Location:		GPS Easting:	2900541.392
Drain Area:	Southwest	GPS Accuracy:	Sub-Meter
Cover Shape:	Circular	Evidence of Surcharge:	No
Cover Size:	22.5	Potential for Runoff:	None
Comments:

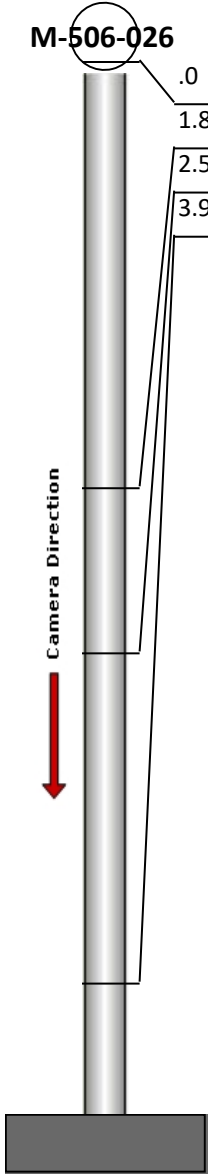
.0	MGP	General Photo	10	NA
	1.8	DAZ	Deposits Attached Other	25	M 2
	2.5	MGP	General Photo	40	NA
	3.9	MGO	General Observation	57	NA
