Manhole Inspection Report

Date:	09/28/2022	Weather:		Coding:	RZMACP
MH#:	M-506-028	Owner:	NA	Len. Surveyed:	9.1
P.O.#:		Surveyor:	Jen Costello	Rim to Invert:	10.0
Customer:		Cert. #:	U-907-5518	Wall Material:	Brick

Street:	North of 7th Pl. 67' East of River Ter	Project:	Hobart, IN
City:	Hobart, IN	GPS Northing:	2286907.368
Location:	Yard	GPS Easting:	2900211.312
Drain Area:	Southwest	GPS Accuracy:	Sub-Meter
Cover Shape:	Circular	Evidence of Surcharge:	No
Cover Size:	24.0	Potential for Runoff:	None
Comments:

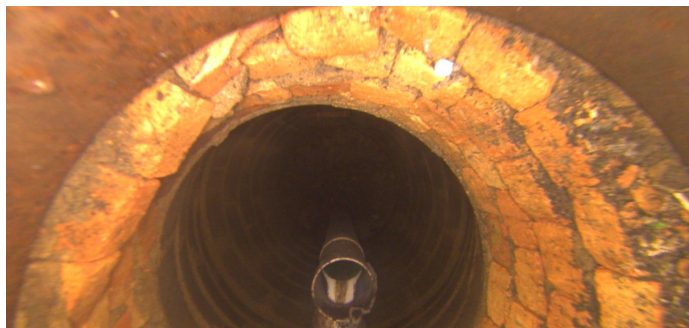
Code: **MGO**
Description: **General Observation**

Distance (ft): **.0**
Structural Grade: **0**
O&M Grade: **0**
Clock Start/From:
Clock To:
1st Value:
2nd Value:
Value Percent:
Step: **NO**
Remarks: **access mh**

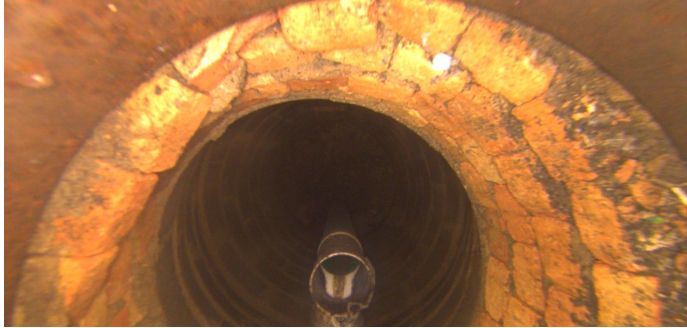
Code: **MGO**
Description: **General Observation**

Distance (ft): **.0**
Structural Grade: **0**
O&M Grade: **0**
Clock Start/From:
Clock To:
1st Value:
2nd Value:
Value Percent:
Step: **NO**
Remarks: **access mh**

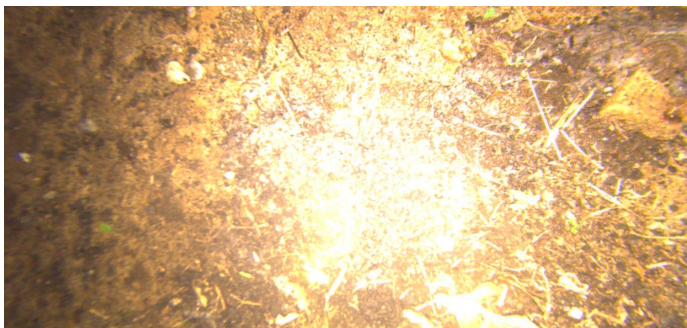
Code:	MGO
Description:	General Observation
Distance (ft):	9.1
Structural Grade:	0
O&M Grade:	0
Clock Start/From:	
Clock To:	
1st Value:	
2nd Value:	
Value Percent:	
Step:	NO
Remarks:	end of survey
