Manhole Inspection Report

Date:	04/24/2018	Weather:		Coding:	RZMACP
MH#:	M-506-030	Owner:	NA	Len. Surveyed:	5.7
P.O.#:		Surveyor:	John Kuglmaier	Rim to Invert:	6.7
Customer:		Cert. #:	U-1215-07002349	Wall Material:	Concrete (reinforced)

Street:	River Terrace 270' West of Colorado	Project:	Hobart, IN
City:	Hobart, IN	GPS Northing:	2900278.81
Location:		GPS Easting:	2900278.81
Drain Area:	Southwest	GPS Accuracy:	Sub-Meter
Cover Shape:	Circular	Evidence of Surcharge:	No
Cover Size:	22.5	Potential for Runoff:	None
Comments:

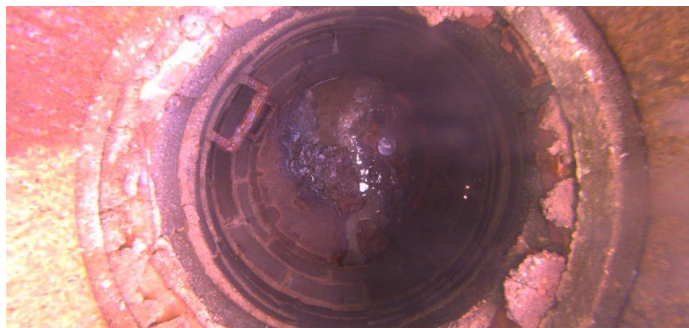
Code: **MGP**
Description: **General Photo**

Distance (ft): **.0**
Structural Grade: **0**
O&M Grade: **0**
Clock Start/From:
Clock To:
1st Value:
2nd Value:
Value Percent:
Step: **NO**
Remarks:

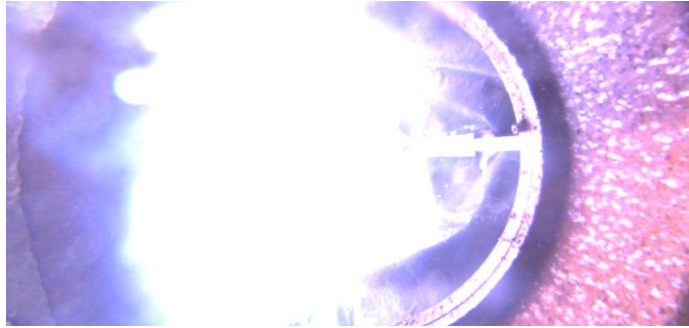
Code:	MGP
Description:	General Photo
Distance (ft):	2.0
Structural Grade:	0
O&M Grade:	0
Clock Start/From:	
Clock To:	
1st Value:	
2nd Value:	
Value Percent:	
Step:	NO
Remarks:
