Manhole Inspection Report

Date:	04/24/2018	Weather:		Coding:	RZMACP
MH#:	M-506-032	Owner:	NA	Len. Surveyed:	9.2
P.O.#:		Surveyor:	John Kuglmaier	Rim to Invert:	9.9
Customer:		Cert. #:	U-1215-07002349	Wall Material:	Concrete (reinforced)

Street:	7th Pl. and River Terrace. To the Nor	Project:	Hobart, IN
City:	Hobart, IN	GPS Northing:	41.526371
Location:		GPS Easting:	-87.27546692
Drain Area:	Southwest	GPS Accuracy:	Nearest Meter
Cover Shape:	Circular	Evidence of Surcharge:	Yes
Cover Size:	22.5	Potential for Runoff:	None
Comments:

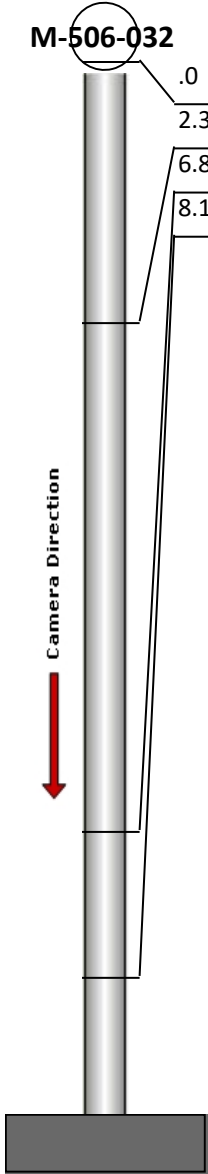
0.0	MGP	General Photo	10	NA
	2.3	MGP	General Photo	28	NA
	6.8	DAZ	Deposits Attached Other	51	M 2
	8.1	MGO	General Observation	65	NA
