Manhole Inspection Report

Date:	04/24/2018	Weather:		Coding:	RZMACP
MH#:	M-506-033	Owner:	NA	Len. Surveyed:	10.6
P.O.#:		Surveyor:	John Kuglmaier	Rim to Invert:	10.9
Customer:		Cert. #:	U-1215-07002349	Wall Material:	Concrete (reinforced)

Street:	Intersection of 8th St. and Colorado	Project:	Hobart, IN
City:	Hobart, IN	GPS Northing:	2900536.241
Location:		GPS Easting:	2900536.241
Drain Area:	Southwest	GPS Accuracy:	Sub-Meter
Cover Shape:	Circular	Evidence of Surcharge:	No
Cover Size:	22.5	Potential for Runoff:	None
Comments:

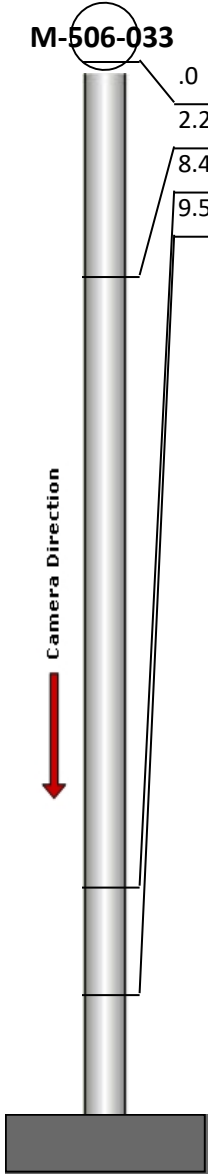
M-506-033				
	.0	MGP	General Photo	10	NA
	2.2	MGP	General Photo	28	NA
	8.4	DAZ	Deposits Attached Other	54	M 2
	9.5	MGO	General Observation	68	NA
